Use Attainability Analysis

WBID 2372 Tributary to Davis Creek

Submitted by  
SES, Inc.

To  
Missouri Department of Natural Resources  
Water Protection Program

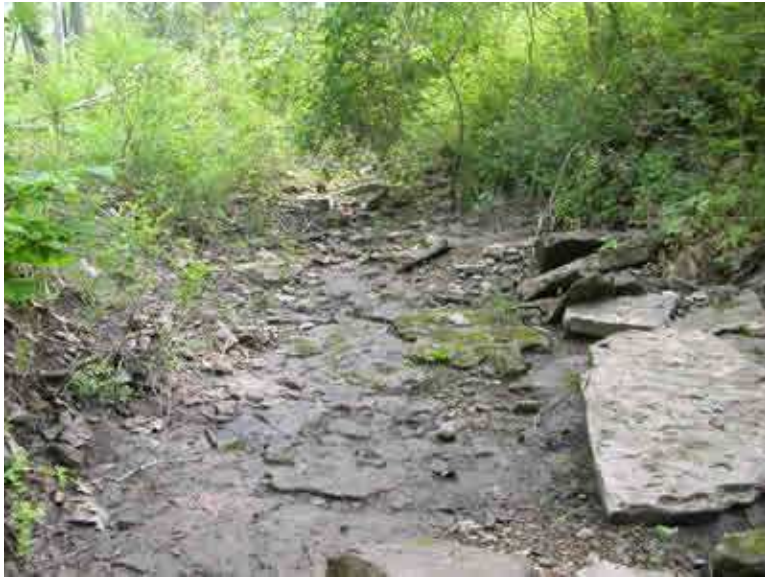
**Site# 1 Photo ID# 3, Downstream**

**WBID #** 2372      **Site #** 1  
**Mark #** 1      **Dissolved Oxygen (ppm)** N/A (dried up)  
**Upstream Views Physical Dimensions:** Is there any water present at this view? no

**Downstream View's Physical Dimensions:** Is there any water present at this view? no

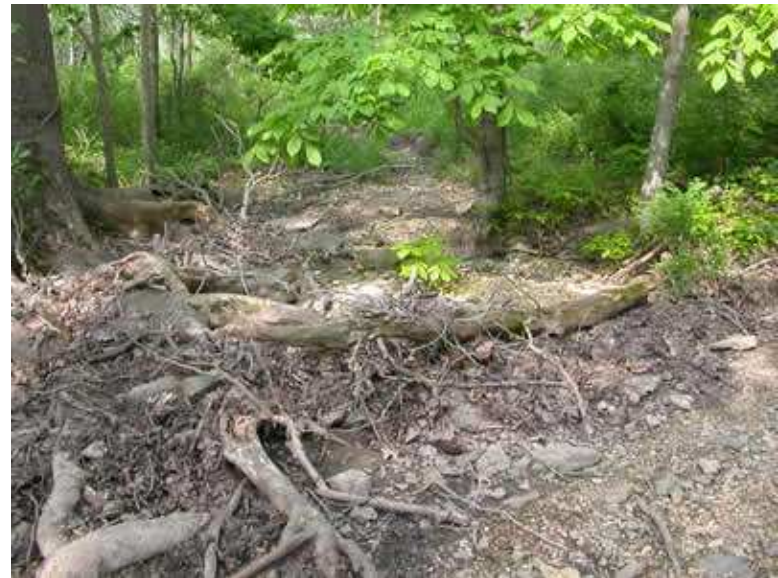
**Site# 1 Photo ID# 2, Upstream**

If so, is there an obvious current? no

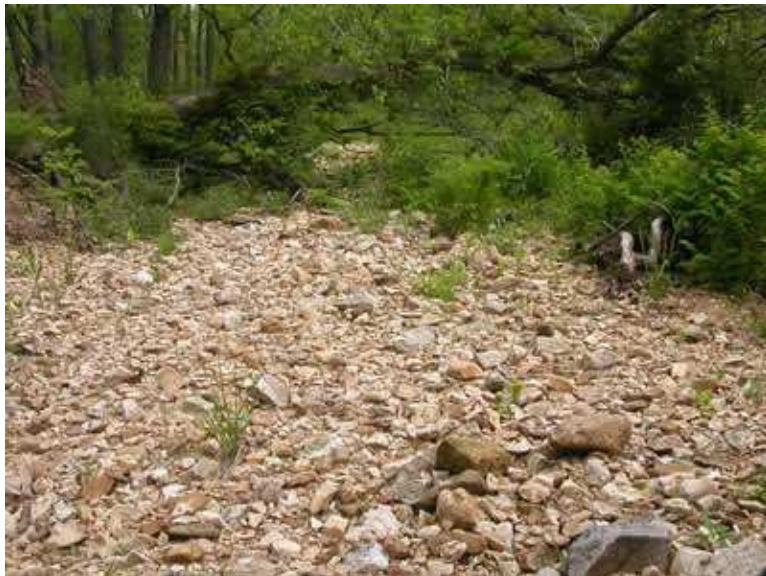
**Site# 2 Photo ID# 7, Downstream**

**Downstream View's Physical Dimensions:** Is there any water present at this view? no

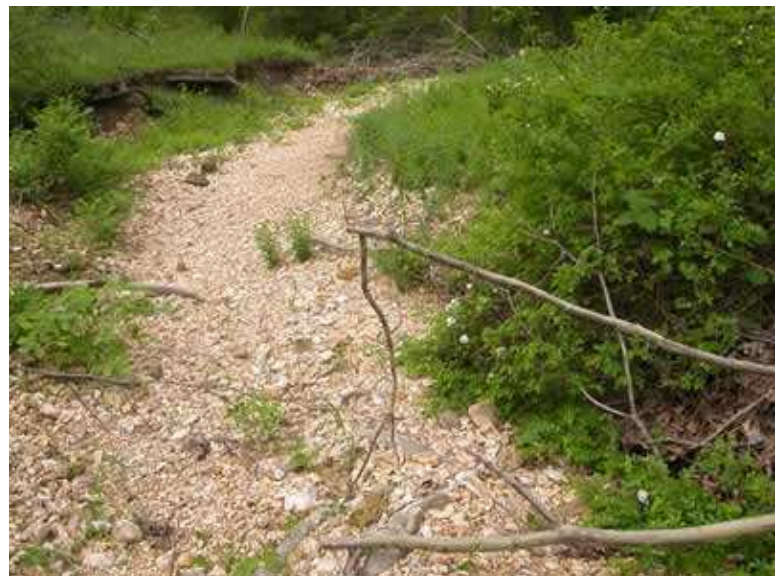
**Site# 2 Photo ID# 6, Upstream**

**WBID #** 2372      **Site #** 2  
**Mark #** 3      **Dissolved Oxygen (ppm)** N/A (dried up)  
**Upstream Views Physical Dimensions:** Is there any water present at this view? no

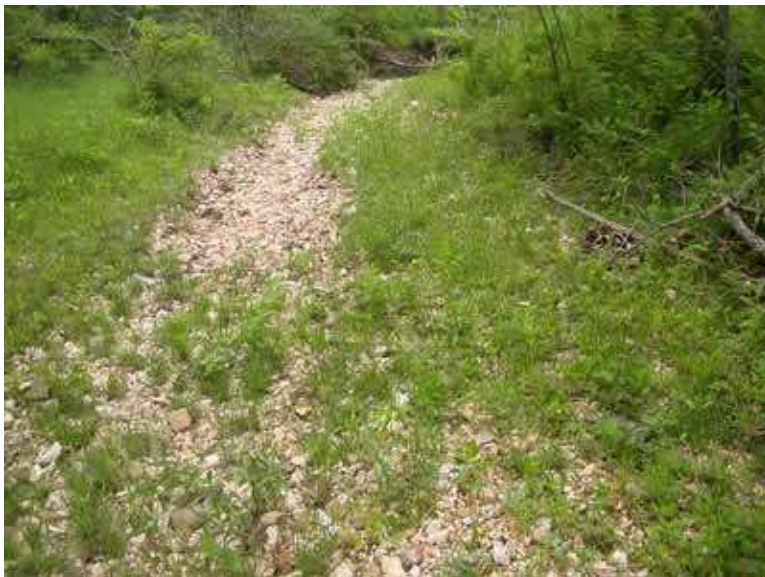
**Site# 3 Photo ID# 5, Downstream**

**Downstream View's Physical Dimensions:** Is there any water present at this view? no

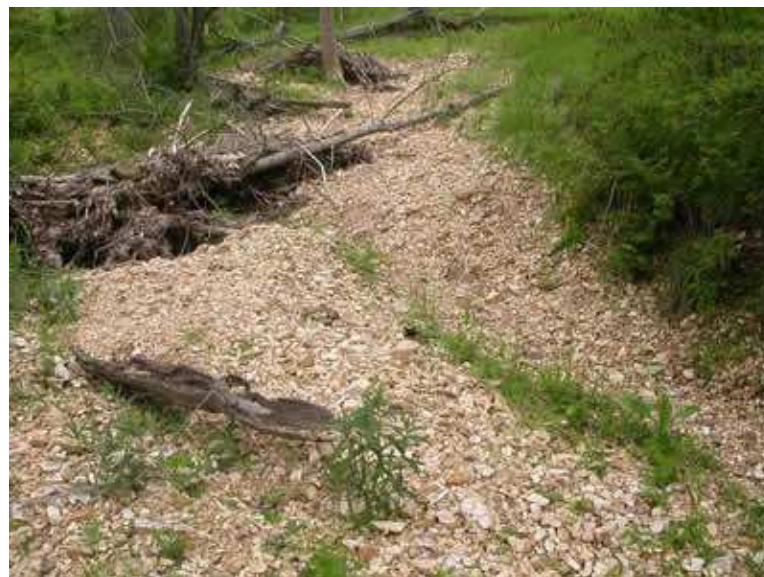
**Site# 3 Photo ID# 4, Upstream**

**WBID #** 2372      **Site #** 3  
**Mark #** 2      **Dissolved Oxygen (ppm)** N/A (dried up)  
**Upstream Views Physical Dimensions:** Is there any water present at this view? no
